Process Doctor

Activate That Flux!

Moisture absorbed by poorly activated flux residues coupled with other ionic residues can cause failures.

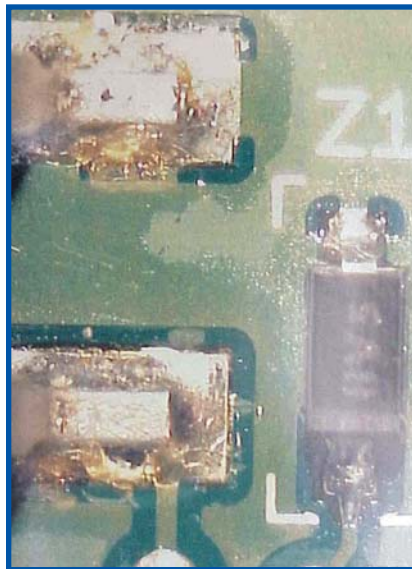
The same component area showed high levels of weak organic acids on all modules examined. Weak organic acids, such as succinic or abeitic acid, are generally benign, but can prove detrimental if not fully activated, which permits them to absorb moisture.

This proved to be the case with the failed modules. The WOAs absorbed moisture, which reacted with the chloride to cause a field failure. The chloride on the affected component would not have been so apt to cause a failure if the WOA flux residues had not absorbed moisture from the air. With the application of a current, the moisture and chloride created a corrosion cell.

FIGURE 1: Area of heavy flux residue on the module.

One of the client's issues was incoming component cleanliness. The problem was magnified by not fully activating the flux used in assembly. Components should be monitored for cleanliness as-received.

This case is also an example of poorly activated weak organic acids becoming highly detrimental when combined with other ionic elements. The poorly activated flux residues were not a problem on their own, but caused a failure mechanism when they absorbed moisture, which reacted with chloride from the dirty components. When not fully activated, flux residues remain in a state that can absorb moisture and react with other ionic residues when a current is applied. This risk-prone state creates a critical need to make sure that flux residues are fully activated. ■
