Process Doctor

Localized Contamination, Big Problems

When it comes to some residues, ROSE testing is not so sweet.

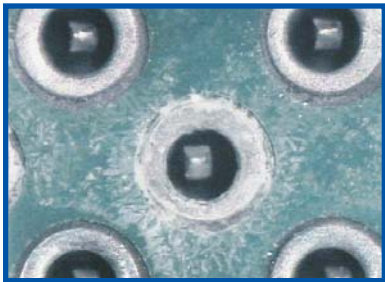
One assembly sample from a plant in Malaysia was sent to our laboratory for analysis. We used FTIR, SEM/EDX and ion chromatography analysis using localized extraction techniques. FTIR analysis showed only flux residues. SEM/EDX showed a concentration of tin, lead, oxygen and copper. The high concentration of tin and lead caused us to deduce that electromigration was occurring in this area, creating the white residue presence and visible dendritic growth (see figure). Because of these findings, we decided to analyze the area of white residue using ion chromatography in order to better understand what contaminants were present and what they indicated about the manufacturer's process.

Localized white residue on assembly.

Using a C3 localized cleanliness tester, we extracted a residue sample from a 0.1 in² area on the connector area and its casing, and a reference area on the connector area and casing. The tester showed "dirty" readings for the connector area, with white residue presence and its casing area (Table 1). Examining the reference areas on the connector and casing, we received "clean" readings for both. We took these four extracted samples and performed IC analysis. We found high levels of chloride, sulfate and

weak organic acid (WOA) flux residues on the visible white residue sample from the connector and its casing. Conversely, we detected low and acceptable levels of ionic residue species on our two reference areas. This led us to believe that an external fluid contaminant had been introduced at some point and caused the visible white residues and dendritic growth. Looking at the board, the white residue appeared in a line like that of a drip, possibly caused by tap water, which tends to be high in chloride and sulfate.

We recommended that the customer monitor assembly processes more closely and determine the cause of the external fluid contaminant that was creating this reliability issue.
