# Mean Green Corrosion

## Avoiding residues on ImAg boards selectively soldered with no-clean flux.

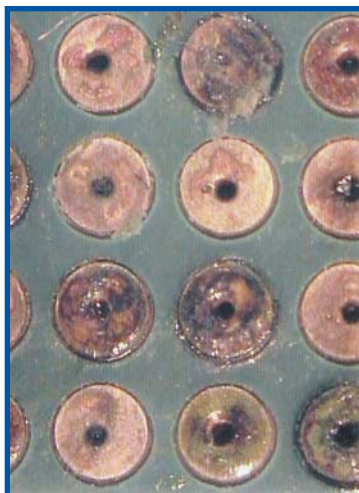
**N**o-clean fluxes are designed to be protective and insulative of boards, but in selective soldering fluxes often fail to become fully complexed, leaving harmful conductive residues on the board. This effect can be seen on all types of board finishes, but ImAg is particularly sensitive to the aggression of no-clean flux residues.

In one case, a customer was assembling ImAg-finished boards using a VOC-free water-based no-clean flux. Failures were occurring around selective soldering sites, which showed a green corrosion (Figure 1). We were sent seven assemblies, four bare boards and a flux sample for failure analysis. Using the C3 tool, we extracted localized samples around the failure sites. These samples were then used for ion chromatography analysis in a Dionex ICS 2000 system per IPC-TM-650 2.3.28 to identify and quantify ionic residue species present. Upon analysis, these sites showed marginal-to-low levels of chloride, but some levels were high enough to indicate a contribution to the attack on the silver and copper. The levels were not high enough to be the primary cause of the green corrosion. These sites did, however, show very high levels of weak organic acid (WOA) flux residues and a water carrier. These residues are very hygroscopic, and are the primary cause of the visible copper chloride corrosion. We also tested the pH around the areas of corrosion. On a failed area pH measured 1.7, while on a reference area pH measured 7.7. This shows how the typical residues on ionically clean areas of the board are neutral, while the no-clean flux and water residues leave a strong acid on the silver finish.

FIGURE 1: No-clean flux boards before rescue cleaning ...

Based on the findings and our experience in developing cleaning protocols for no-clean assemblies, a rescue cleaning protocol was developed to recover the boards. Using 10% saponifier and 90% DI water with regular in-line cleaning, we removed the corrosion and

decreased ionic residue levels to within the parameters for long-term field performance.

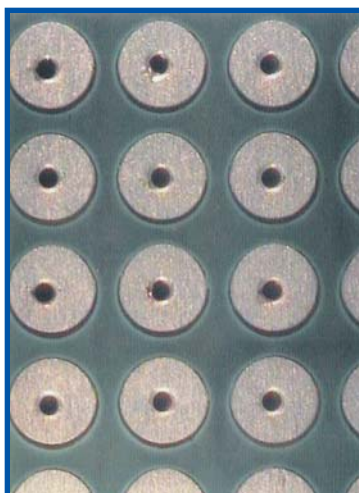
FIGURE 2: ... And after.

In addition, cleaning the pallets prior to use to decrease flux buildup will help with this manufacturing process. In this instance we used Envirogold Envirosense 816 saponifier at 10% in a 140°F bath, and then steam-cleaned the pallets with a PDQ Minimax 2 steamer (Figure 2).
