No Silver Lining

Sulfate contamination causes visible silver crystalline growth.

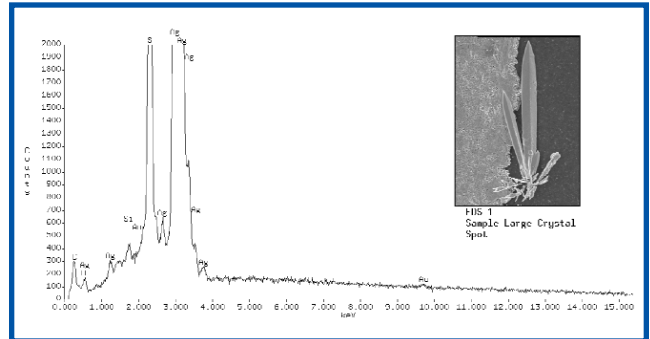
FIGURE 1: Failing open resistor area with visible crystalline growth.

A customer was seeing open resistor failures in the field. On the potting layer of these failing assemblies was a visible crystalline growth (Figure 1). This growth appeared to be occurring right at the epoxy/solder interface. The client sent failing assemblies to Foresite for analysis, with samples of the potting compound, incoming components and materials.

One other area of concern was found, though. The incoming resistors were noted to be high in sulfate residues. The client revealed that the component vendor used an end-termination plating process that had the potential to entrap harmfully corrosive methane sulfonic acid (MSA). This residue was becoming entrapped at the epoxy/solder interface. Often with this level of measurable sulfate contamination, it takes a good deal of time and moisture to propagate a corrosion event at the silver layer across a part at the epoxy interface. This explains the spanning time differential between the failed units examined.

believe that such crystals can be prevented if ionic cleanliness is kept in check. Because we are so concerned that incoming components and materials are RoHS compliant, perhaps we should make ionic cleanliness an equally critical concern to ensure the long-term reliability of products.
