# What's My Risk?

## Determining the root cause of a field failure.

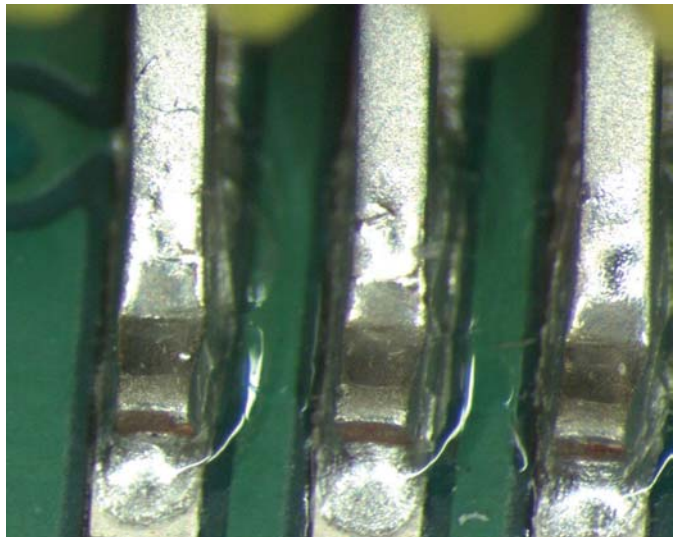
What is the root cause? The sensitive area of the circuit near the connector is isolated as having the performance problem (**Figure 1**). New components hand-soldered into failed locations perform well. Cleaning with a brush and IPA between the leads improves the performance for a few hours in the humidity chamber (without cleaning, the boards fail in 20 min. in a  $40^\circ\text{C}/90\%$  RH conditions, whereas brush cleaning permits 3 hrs. in a biased state).

**Figure 1.** Sensitive circuit area on the bottom-side SMT of a no-clean assembly. The area is next to the connector, which is wave-soldered in a selective pallet.

Further, C3 extractions of localized areas around the sensitive area of the circuit show very high levels of WOA residues ( $229 \mu\text{g}/\text{in}^2$ ) as compared to other areas on the bottom-side SMT area, away from the selective pallet, with WOA levels at  $11.3 \mu\text{g}/\text{in}^2$  and  $9.41 \mu\text{g}/\text{in}^2$ . The area inside the selective soldering process that was in contact with the wave solder showed WOA levels of  $44.35 \mu\text{g}/\text{in}^2$  and  $37.19 \mu\text{g}/\text{in}^2$ . The amount of clear flux around the leads was greater near the selective solder area. Capacitors were growing dendrites on the top and side of the component next to the area of selective solder. The use of a water-based, low-solids no-clean flux with a pH of 2.4 applied with a spray-fluxing process during the wave soldering and pallets that leave a white and clear residue in the pallet area after soldering is the root cause of the performance problem.

This residue is drawn into the areas defined by the selective solder pallet that are designed to protect the bottom-side SMT components from the wave solder area. The capillary forces of the flux will wick into the areas nearby, and the pallet thermally protects the residues from seeing the proper temperature to heat-activate the flux and drive the water from the activator, therefore leaving behind a strong acid with moisture-absorbing elements and creating a leakage and corrosion pathway with the partially heat-activated fluxes. No-clean low-solids flux residues are insulative and benign if they are properly heated (per the manufacturer's recommen-
