We're All Fed Up

Recreating failure mechanism in ovens
Foresite Inc.

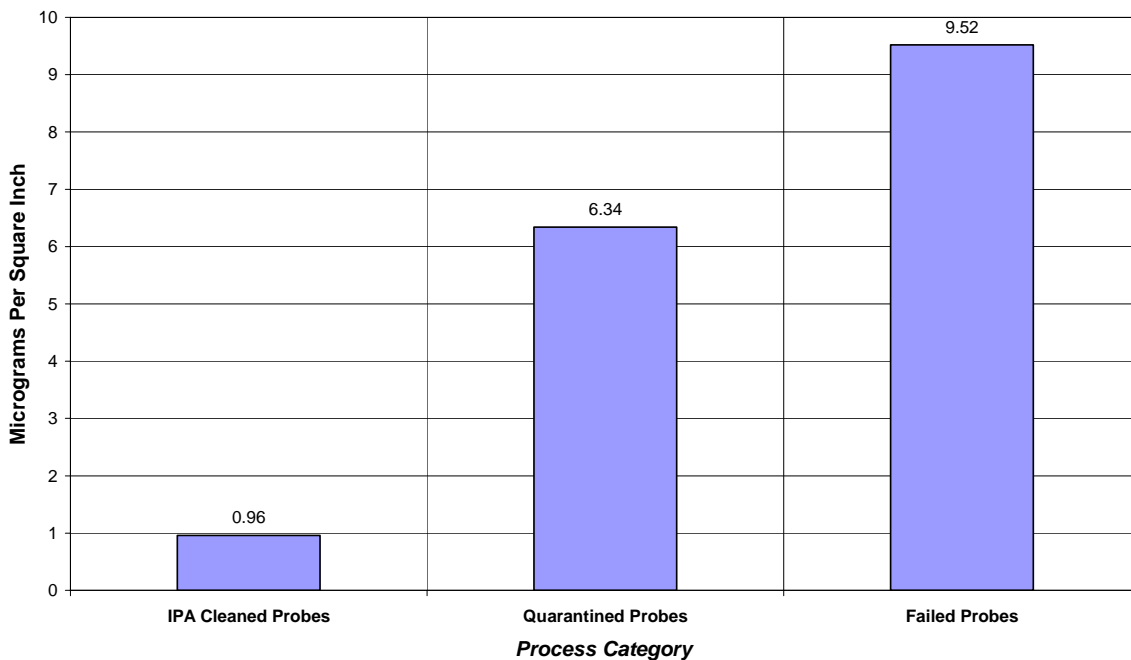
Chart 1
Chloride Levels on Oven Probes

Chart 1 shows the analysis of the probe assemblies and materials by ion chromatography.

- The failure mode was electrochemical migration between the two wires used to attach to the probes.
- There was no single problem to correct, but a series of problems
- There were high levels of chloride in the wire attach areas. The current production probes, which were cleaned, had little to no chloride and no failures could be forced. The failed units had high levels of chloride as did the units in quarantine
- The stainless steel enclosures for the tubes were thought to be fully crimped, isolating the two ends of the probe. This was not the case and moisture laden air could escape through the probe opening, especially when the (primary) oven vent through the range top was blocked by other kettles
- There were a number of odd manufacturing practices in use at the Mexico facility including improper use of a wave solder de-drossing agent

The customer implemented a number of process reforms in the new facility, including a cleaning process for the probes after wire attach. The quarantined probes were cleaned to adequate halide levels. Efforts are under way to improve the crimp seal in the stainless steel housing to prevent oven air from escaping through the probe unit. The manufacturer is also planning on getting away from the use of halide-bearing fluxes in order to eliminate the cleaning process.

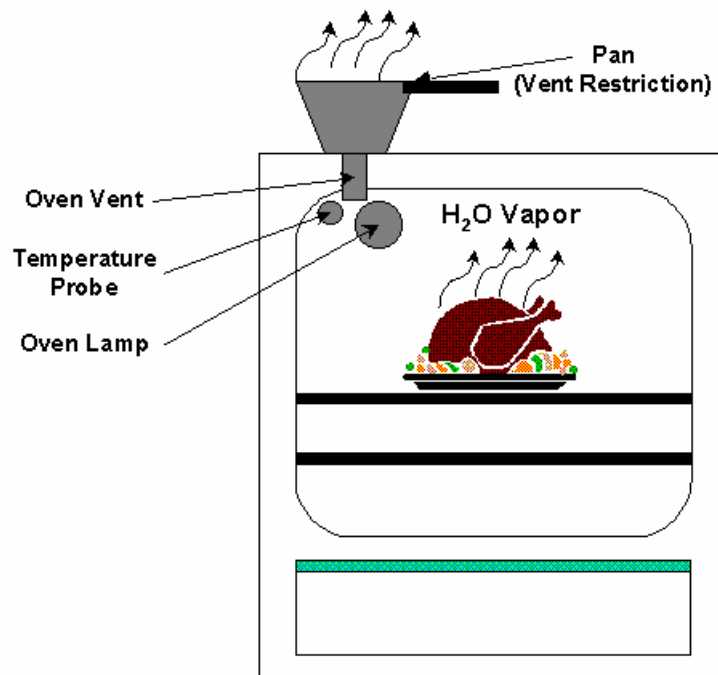
Figure 1.

The customers were a manufacturer of thermocouple probes that were used to control household oven / range units, and the manufacturer of the ovens themselves. Over the Christmas season, a high incidence of failure was noted on the newest oven units, usually with very little service time. The failures seemed to occur more when turkeys and hams were baked, or when the ovens were subjected to the high temperature self-cleaning process. Figure 1 shows the oven diagram.
