Garbage in = Garbage Out

Effects of Elevated Bromide on the Qualification Process
Foresite Inc.

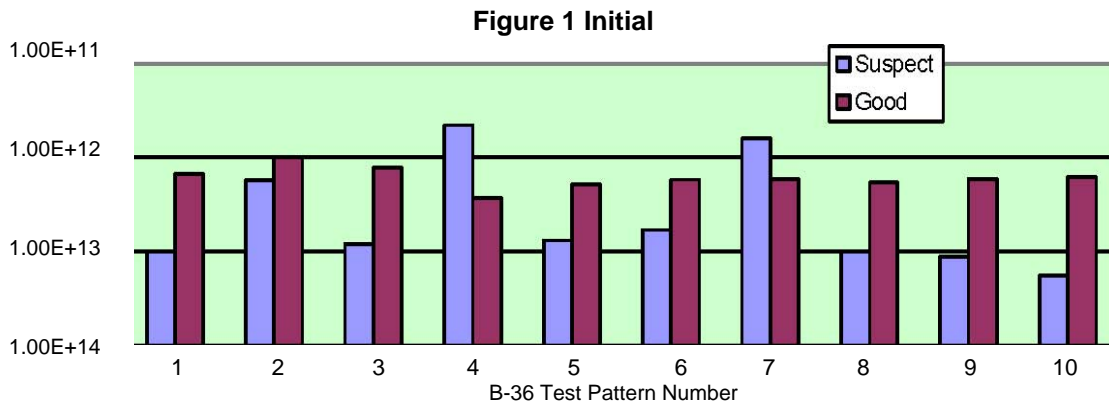
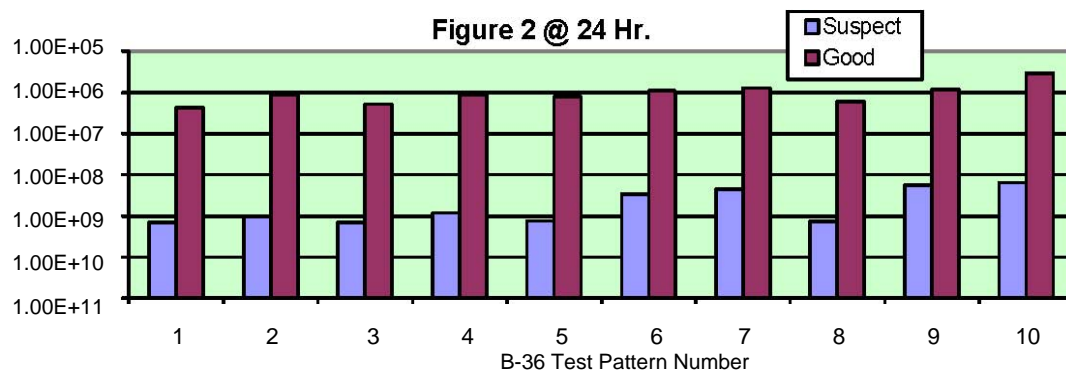
In the initial round of SIR tests, poor performance was noted for the candidate process boards, the baseline RMA process boards and the controls. After determining that the failures were not due to chamber faults or operator errors, the performance of the control boards suggested a fabrication residue. Figures 1 and 2 show some of the SIR characteristics of the control boards (suspect boards) against the performance of control boards from another vendor (good boards).

- The suspect and good boards had comparable SIR levels at initial ambient conditions. No faults would be noticed at this point.
- The 24 hour readings (@85°C & 85%RH) for the good boards were what we consider acceptable performance and typical of a clean board B-36 board and use these levels as a reference.
- The 24 hour readings for the suspect control boards were significantly lower, failing J-STD-001A criteria. This poor performance continued for the remaining measurement sets.

If the control boards had exhibited acceptable SIR levels, then the examined assembly processes would have been suspected. Since the suspect control boards universally failed, it was apparent that an underlying residue affected the results.

After the implementation of the alternative flux in board fabrication, SIR performance improved dramatically. The new B-36 boards performed as denoted in Figure 1. "Good" controls. The customer was able to accurately test the baseline and candidate processes without the background effects of the process residues.

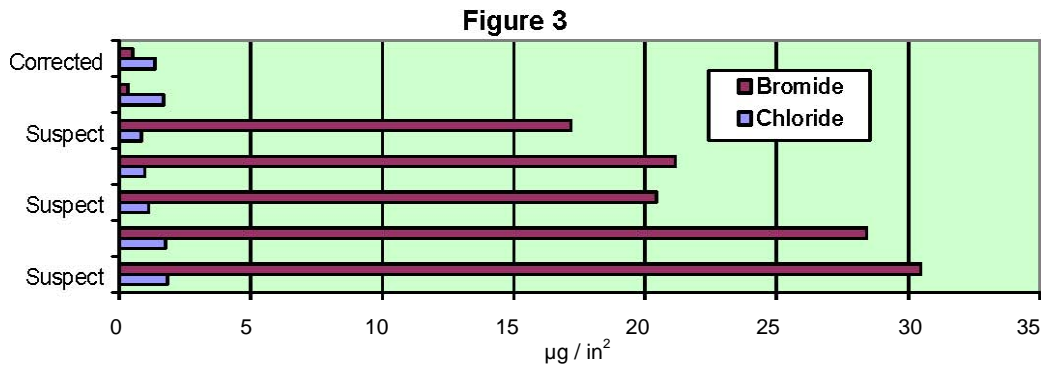
Additional B-36 boards were fabricated using the suspect process. Ion chromatography was performed on the unprocessed boards (as fabricated). Figure 3 shows the general levels of ionic residues found.

- The chloride levels on the process boards were relatively low, but the levels of bromide were unacceptably high. The source was the bromide-activated flux used in the HASL process.
- Bromide levels of 0-4 micrograms per square inch could be attributable to the fire retardant in the FR-4 laminate. The remainder was flux residue.
- The fabricator was encouraged to try an alternative flux in the HASL process which did not contain high levels of chloride or bromide. Figure 3 shows the effects of this change in the columns marked "Corrected".
