## Sure Hope We Don't Get Caught

Make sure that processes on paper match up with process in reality  
**Foresite Inc.**

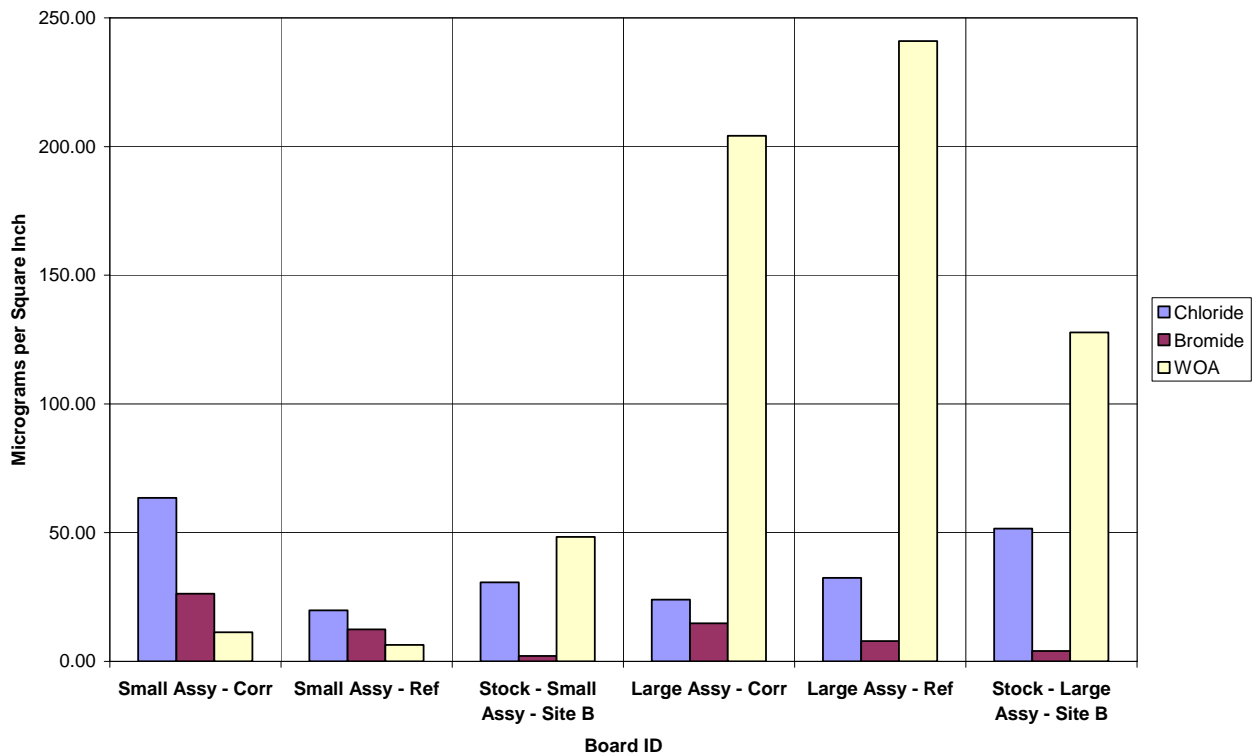
Chart 1 - Residues on Corroded and Stock Assemblies

Foresite was brought into the picture when widespread corrosion, metal migration, and electrical leakage failures were experienced in the field. Chart 1 shows the residue levels on assemblies which experienced corrosion and on stock assemblies produced at Site B, as determined by ion chromatography (IPC-TM-650, method 2.3.28). Site B seemed to have a much higher failure rate than did Site A. This was unusual since the two facilities had nominally the same manufacturing processes using the same materials.
