Leakage, Leakage Everywhere

Carlin Combustion
Foresite Inc.

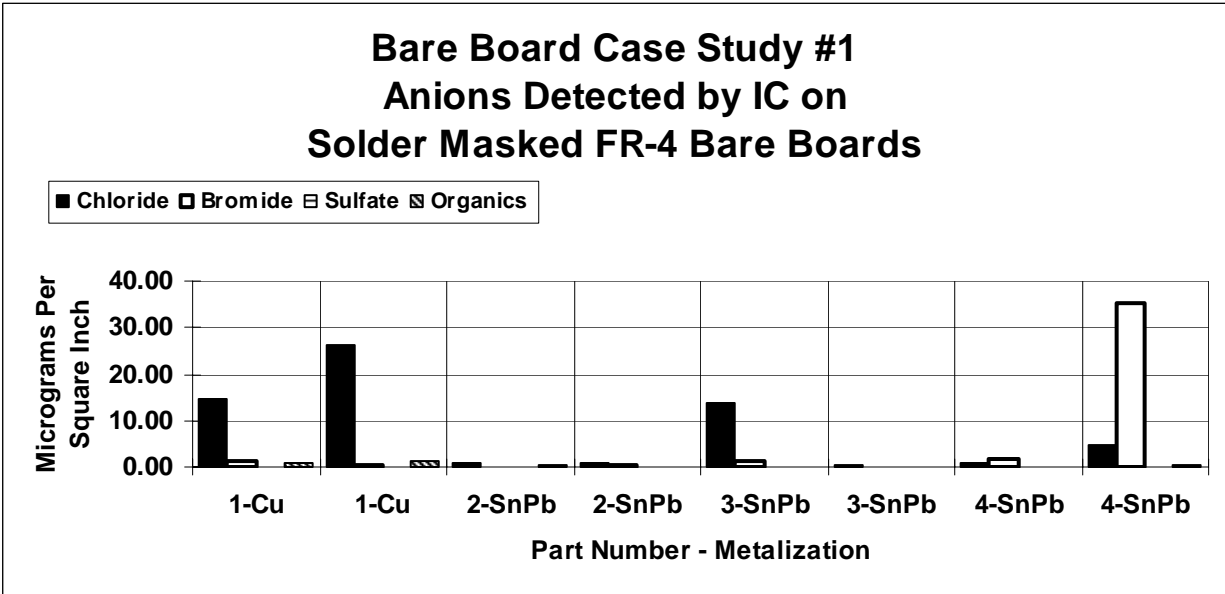
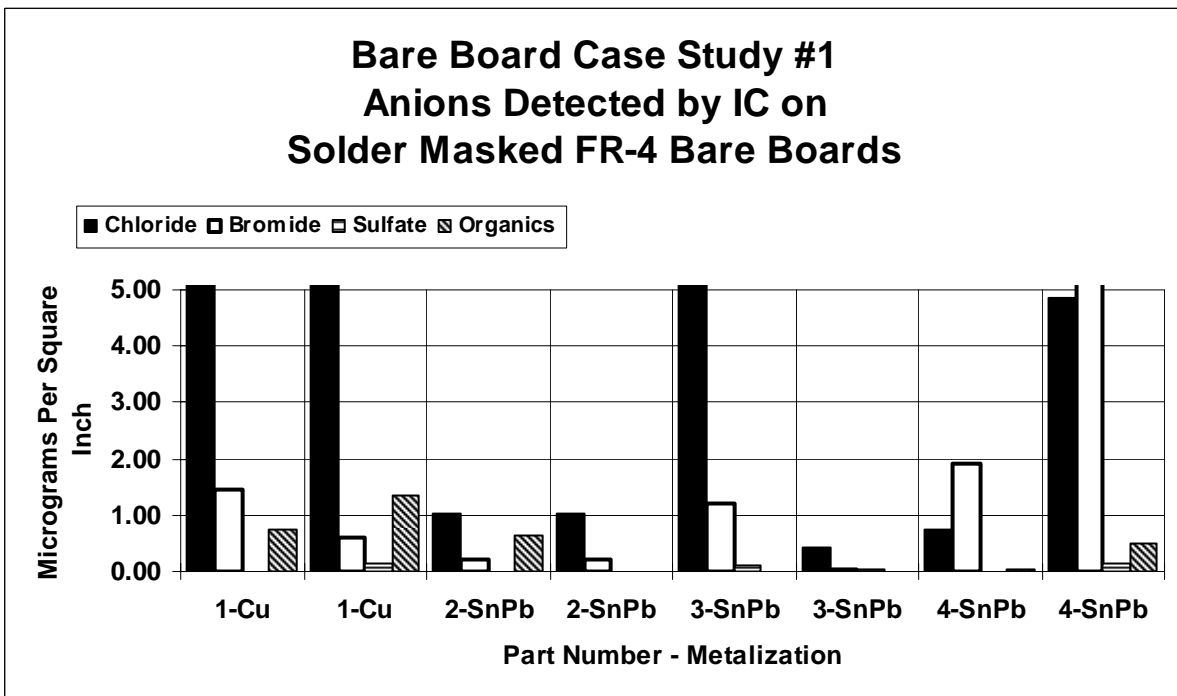
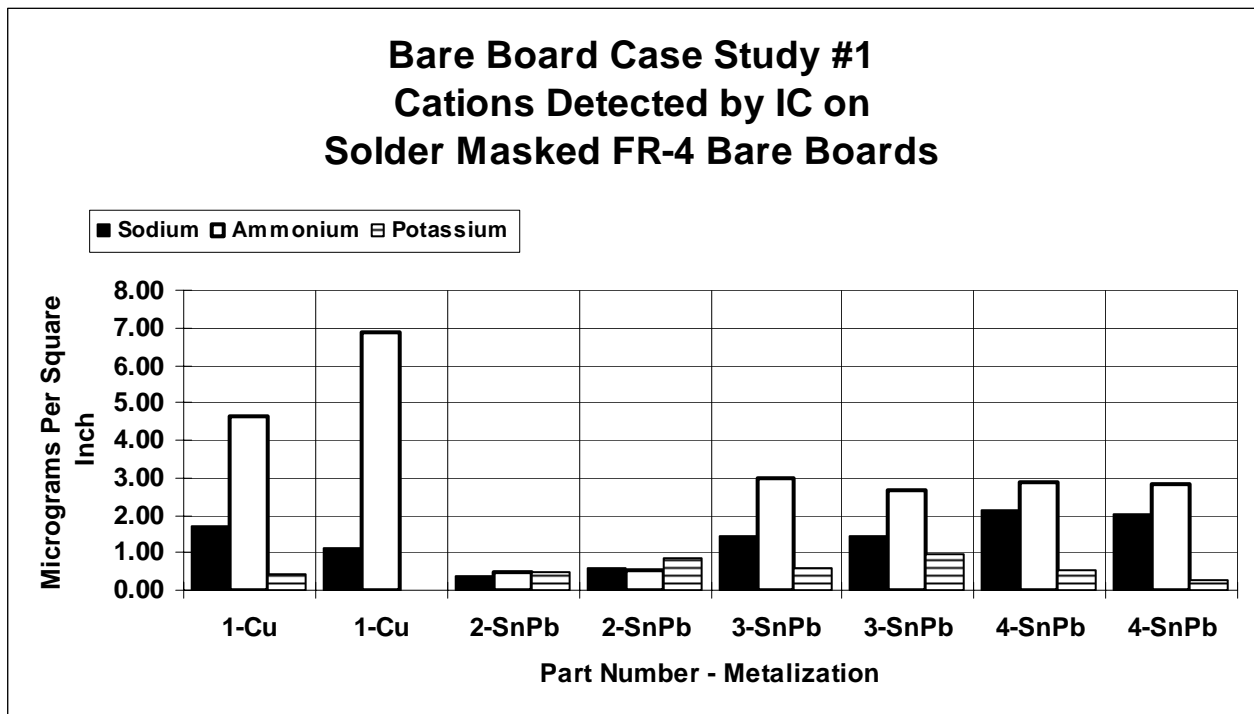
Chart 1-1 through 1-3 show the results of our IC (ion chromatography) analysis for the solder masked FR-4 laminate bare boards. Our study quantified the anion (negatively charged) and cation (positively charged) residues.

- For the bare copper boards (configuration 1), tin-lead coating had been used as an etch resist. Incomplete cleaning left high levels of chlorides, resulting in consistent failures at burn in testing.
- Board configuration 2 was from a known good vendor.
- Board configuration 3 was not consistent in chloride level between samples. This resulted in intermittent performance results in burn-in testing.
- Board configuration 4 was likewise inconsistent, but with bromide (from the HASL flux). High levels of bromide were found on assemblies having leakage problems.
- The cations noted were fairly common to printed assemblies and were not linked to the burn-in failures.

We advised the assembler to work with the fabricator to get the processes under control and assure better incoming cleanliness. We also recommended the assembler conduct remedial cleaning on all existing inventories using a special saponified water cleaning process until the fabricator’s process is brought under control. The remedial cleaning process was successful, as illustrated by Charts 1-7 and 1-8. Once cleaned, the burn-in leakage problems ceased.

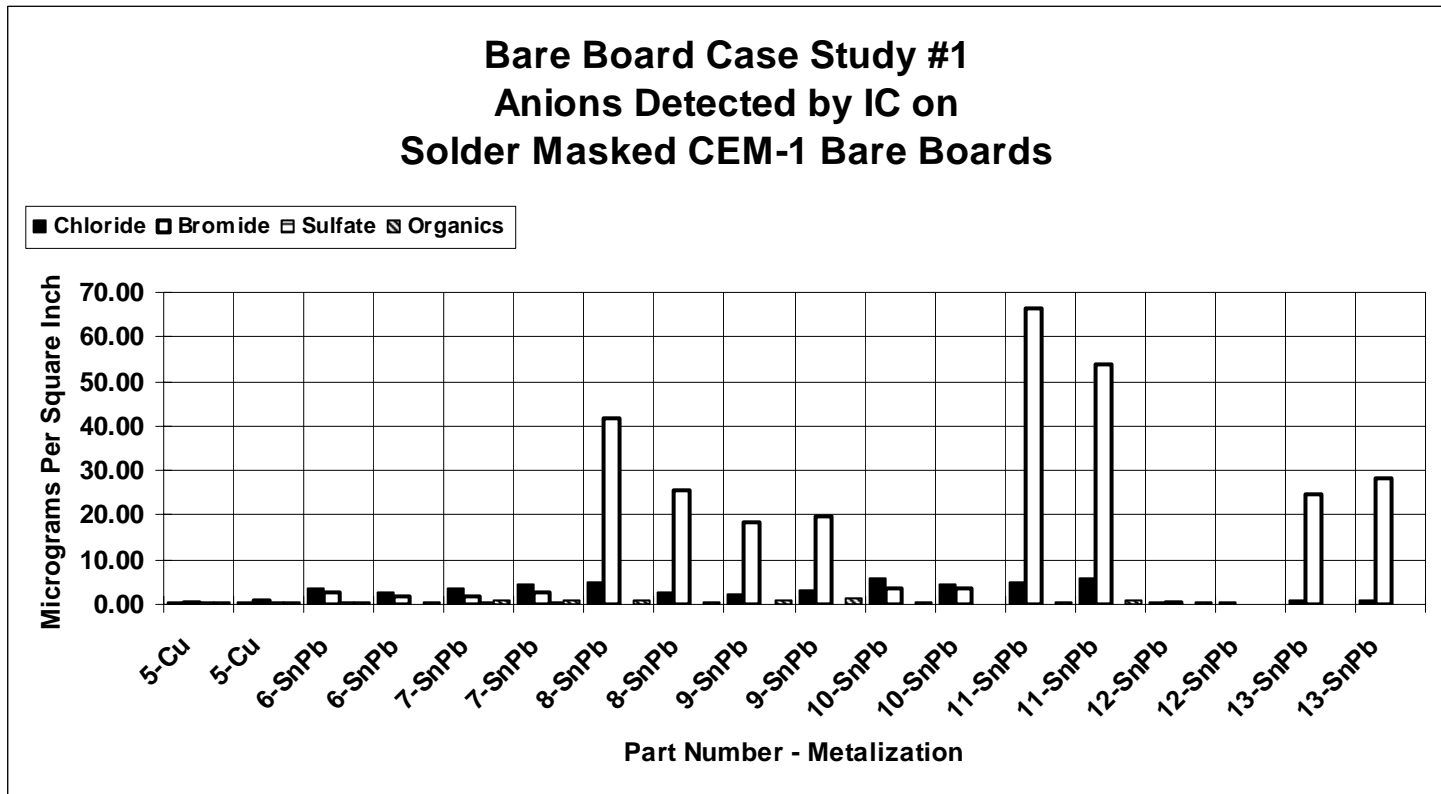
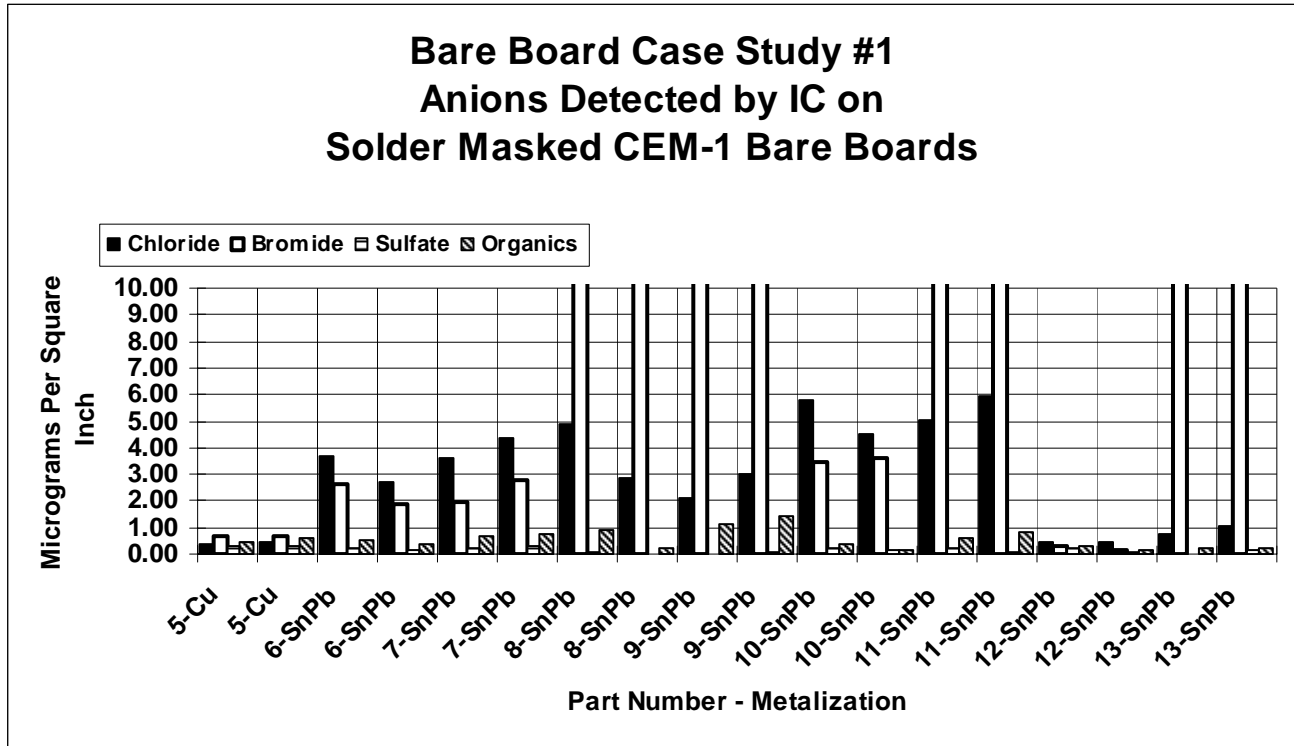
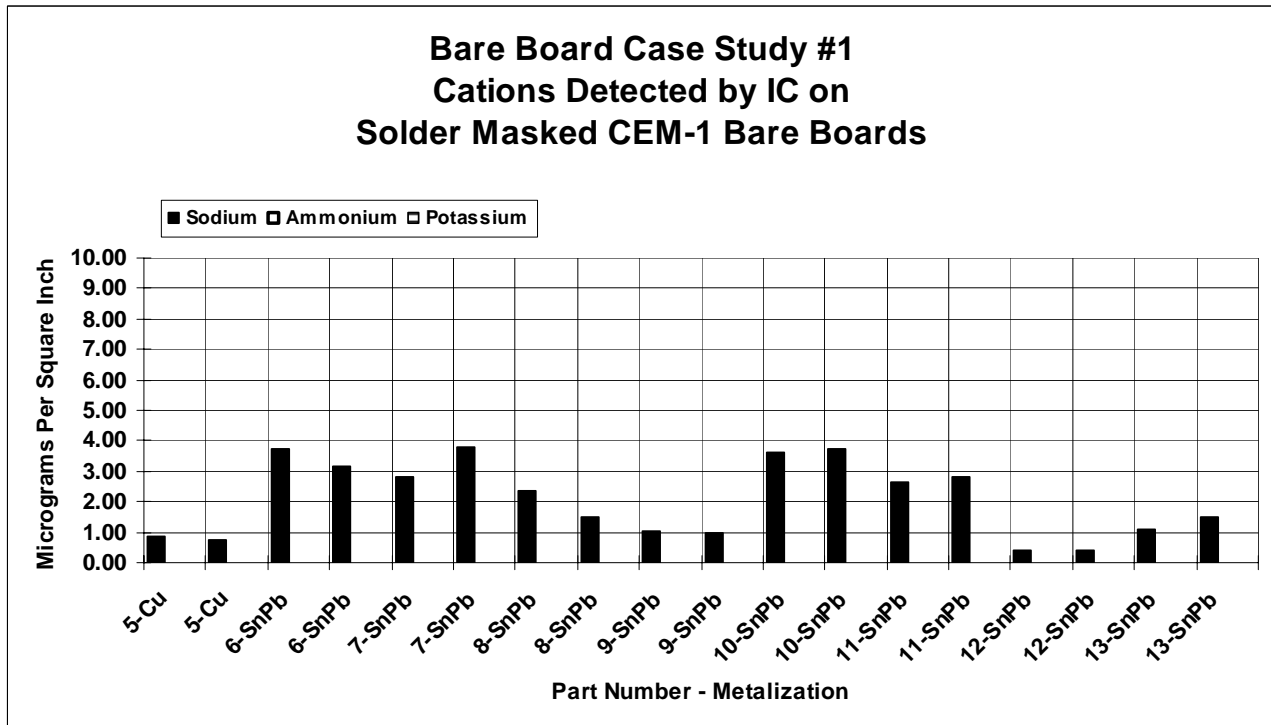
Similarly, Charts 1-4 through 1-6 show the results of the IC (ion chromatography) analysis for solder masked CEM-1 laminate bare boards.

- Board configurations 8, 9, 11, and 13, all had excessively high levels of bromide, resulting in leakage currents and corrosion.
- Board configurations 5 and 12 would be considered as clean and acceptable for a no-clean process.
- Board configurations 6, 7, and 10, had levels of bromide attributable to the fire retardant alone, but had marginal levels of chloride for a no-clean process.
- The cation levels for all boards, with the exception of board 11, were largely unremarkable.
- Board 11 had elevated ammonium levels, when considered together with the elevated halides, indicated virtually no cleaning on this board.
