It Always Works for the Repairman

NTF returns are often the result of an absence of moisture
Foresite Inc.

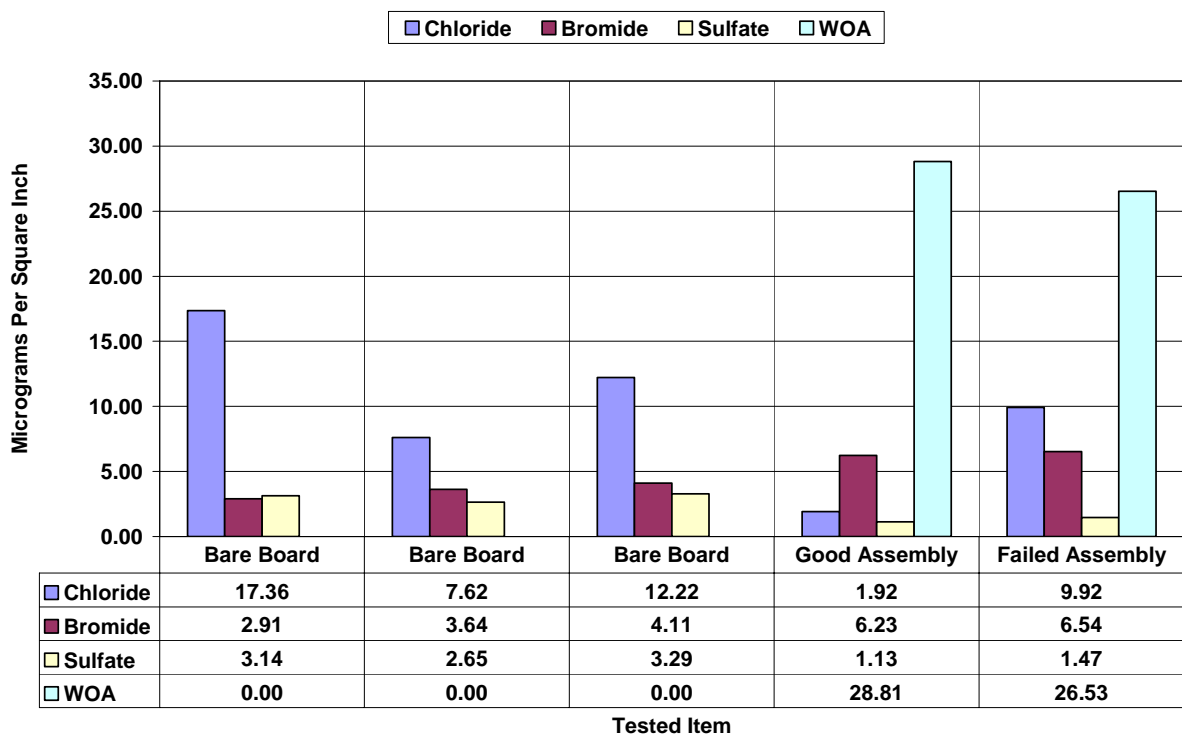
Chart 1 - Residue Levels

The problem was two-fold. The bare boards for this assembly had very high chloride and polyglycol residues. As a reference, we recommend chloride levels of less than 2.0 micrograms per square inch for bare boards. High levels of ionic residues contribute to electrical leakage currents and to electromigration. The second contributor is often a polyglycol residue, remaining after hot air solder leveling (HASL). Polyglycols are used as the carrier solutions in many HASL fluxes or fusing fluids and serve to attract water, which gives the HASL fluxes some water soluble characteristics. While ion chromatography does not directly measure polyglycols, their presence is often implied when bare board chloride or bromide residues are high. If you didn't clean the halides, you didn't get all the polyglycols either. For an assembly, this means that the presence of polyglycols makes the assembly very sensitive to moisture. The SOT-23 area was contaminated in this manner. The polyglycols attracted the moisture from the environment, initiating the leakage currents. Sometimes just breathing on the suspect area supplies enough moisture to create the failure. After the extraction, neither the polyglycol nor the halides were present to cause the leakage currents.

The next time an assembly fails to exhibit the same electrical leakage modes as found in the field, consider testing the assembly in a higher humidity (90%+) environment, before labeling as a NTF. The next step would be to identify the type and level of ionic contamination present and the source of the contamination as part of a Corrective Action Plan.
