Solderability Problems: Both Residue and Thermal Conditions

Higher thermal mass boards require close examination of soldering profiles and solder deposition
Foresite Inc.

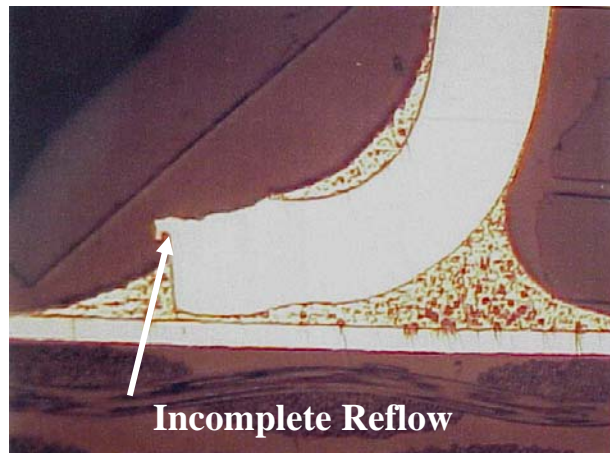
Cross Section of SOIC Termination

Cross sectional analysis of these assemblies showed incomplete solder reflow, poor wetting conditions and non-homogenous alloy structures. Multiple apexes in the solder profile showed that solder was still in the process of wetting when heat was removed, allowing for the solder's surface to be pulled under a high degree of tension, and creating high wetting angles. Flux bubbles and spherical formations of insufficiently reflowed solder were also seen. These conditions were all exaggerated around the larger components such as the failed headers.

After examining all of these results and taking into account the characteristics of this assembly, we made several recommendations. First, we recommended testing bare boards for solderability to see if the added mass of the components created a need for greater thermal energy to be applied during reflow. We also suggested examining solder deposition thickness to see if the appropriate volume of solder is being applied to the boards. Finally, we suggested examining the general reflow soldering profile to see if temperatures were high enough and applied long enough for the solder to become eutectic and form good intermetallic bonds.

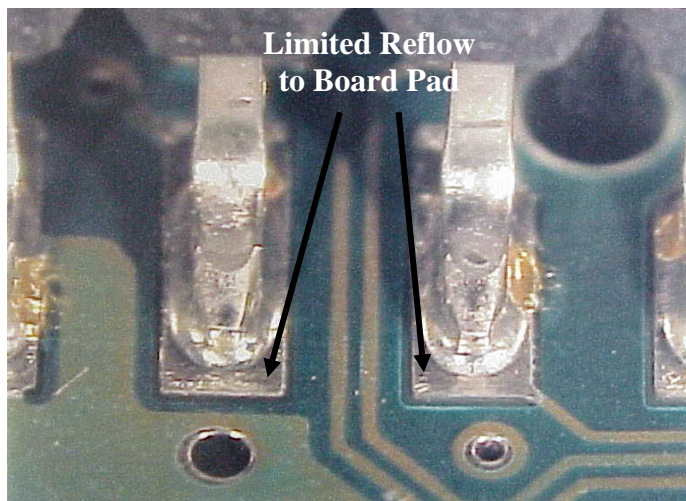
The customer examined in this study was having trouble with connector contacts to headers after reflow soldering on a densely populated assembly. The connector contacts to the headers would come easily detached, and solder was left both on the board and the header. Our investigation of this issue involved both ion chromatography with localized C3 extraction and cross sectional analysis. Localized ion chromatography results of the failure areas on the board showed higher than preferable amounts of chloride and weak organic acid residues. These residues were most likely attributed to flux not being able to completely complex and volatilize due to insufficient heating in the soldering profile for the density of this assembly. If these residues are left on the board without being volatilized, they pose a risk of electromigration or electrical leakage failure.

Condition of Header Reflow (Top Side)
(Typical) Note: Flux Residue

The customer took these recommendations into account, and we tested bare boards for solderability. These samples saw much better solder joints, more homogenous alloy structures and fewer anomalies such as flux bubbles containing ionic residues. Following this analysis, the customer altered the soldering profile to accommodate for the added mass of componentry, and saw much better results in solder bond strength and quality.
