A Problem with Teflon Insulation

Undercure of teflon coated wiring, a fluoropolymer, can lead to harmful corrosion
Foresite Inc.

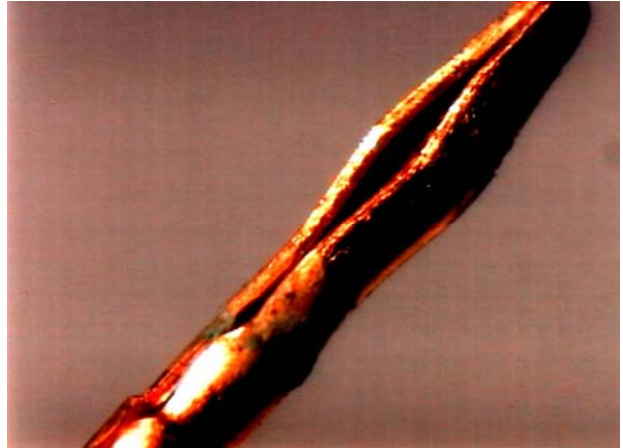
A military customer of these harness assemblies noted corrosion on the connector shells and on the pins of the plastic connectors. A film was noted on the surface of the plastic backshells. Corrosion was noted on gold crimped pins (see photo 1) which had not yet been installed into a connector. The corrosion appeared much more frequently on the white Teflon wires than for colored Teflon wires. The storage environment was 80°F and the bags were heat sealed. No electrical potential existed at any time.

Photo 1: Corroded Gold Pin

Fluoride is one of the most electroactive residues known, and is much more corrosive than chloride. The manufacturer began to experiment with baking (1-12 hours @ 200°F) the Teflon wire to complete the cure. The longer bake time dramatically reduced the amount of fluoride. The manufacturer changed polyethylene bag suppliers and the new bags had no detectable level of fluoride. The manufacturer also went to great lengths to investigate the problem, worked with customers to alert them to the potential corrosion, and worked to determine a cure.

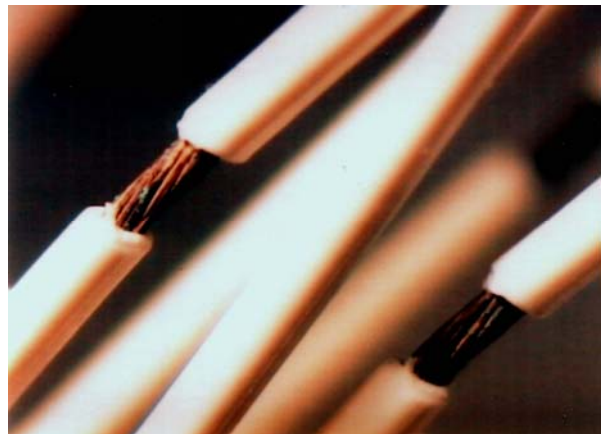
We examined several of the various kinds of wires. Photos 2 and 3 show the corrosion present on the wire at points under the insulation. The corroded areas had not been previously exposed to the outside environment.

Photo 2: Corrosion Under Teflon Insulation

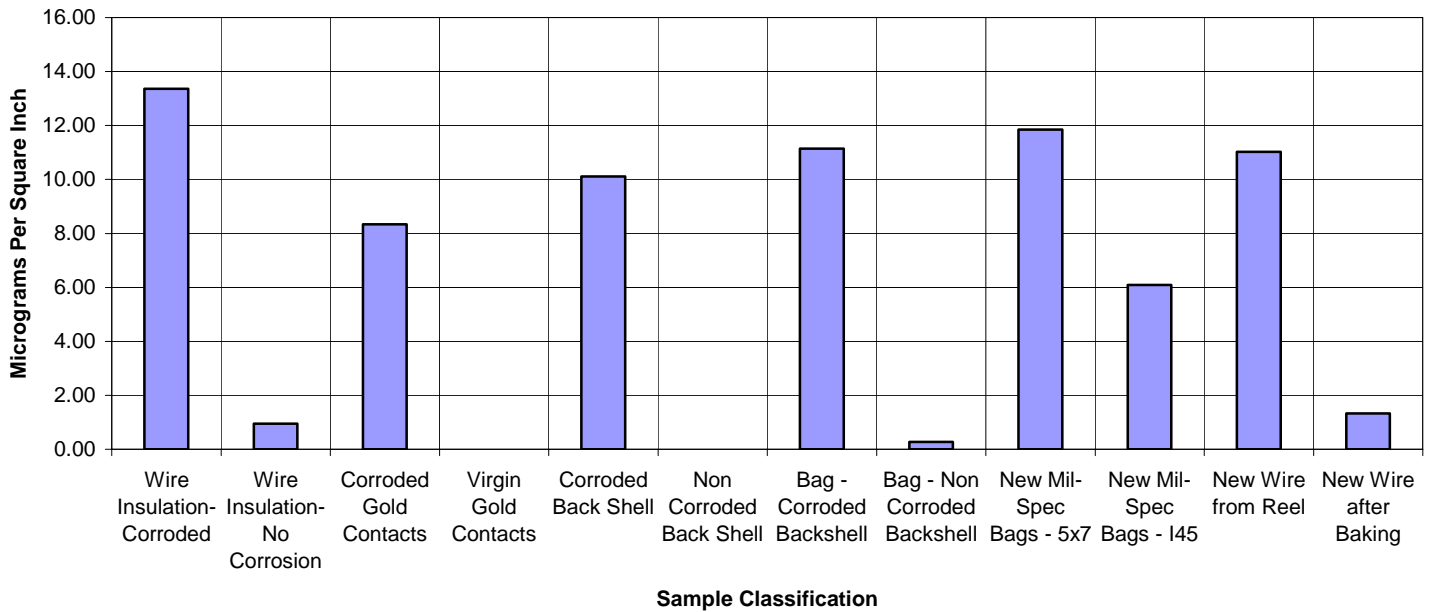
We examined many different samples using ion chromatography. Chart 1 shows the levels found, concentrating on fluoride. We were able to correlate the corrosion to high levels of fluoride. Fluoride levels on corroded backshells often exceeded 50-75 micrograms per square inch. In areas where no corrosion occurred, the fluoride levels were low. Other residues, like chloride and sulfate, were also present, but they did not appear to contribute to this problem. We concluded that there were two sources for the elevated fluoride: the polyethylene bags and undercured Teflon (a fluoropolymer) wire. SEM/EDX analysis also showed the presence of silica on the corroded surfaces. The undercured Teflon outgassed fluoride over time. The silica-based slip agent of the polyethylene bags assisted in the transfer of the fluoride to the corroded parts. It is unknown why the polyethylene bags had such a high level of fluoride.

Chart 1: Fluoride Residue Levels

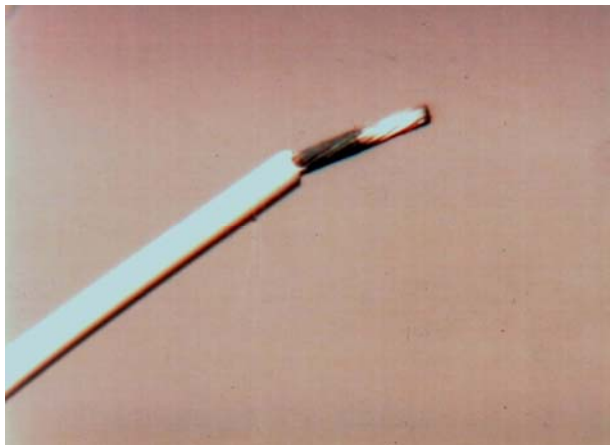
Photo 3: Corrosion Under Wire

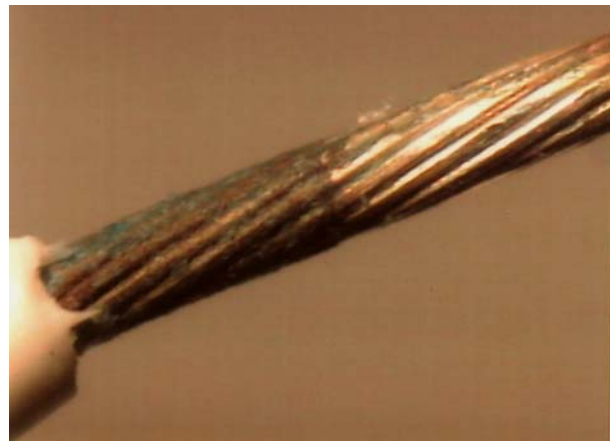
Photo 2: Closeup of Photo 3
