Ventilation Condensation

The Cleanliness of Environmental Chambers
has a Direct Impact Product Performance
Foresite Inc.

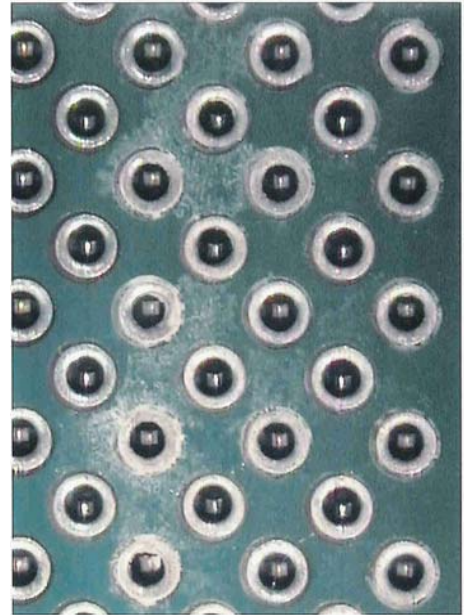
Recently, Foresite has been involved in ongoing process monitoring and failure analysis for a customer manufacturing high density assemblies. You may remember them from our April column about localized residues causing big problems for an assembler. In this case, the manufacturer was seeing dendrites and a visible white residue that appeared to be in a drip pattern around a VHDM connector. These boards were double sided no-clean assemblies utilizing SMT and through-hole technologies on FR-4 laminate. FTIR analysis only showed flux residues. SEM/EDX showed a concentration of tin, lead, oxygen and copper, which was indicative of electromigration related failures. We analyzed the localized connector and housing areas where the white residue and dendrites appeared by extracting a sample with the C3 localized ionic cleanliness tester, and examining the samples with ion chromatography. Our findings showed high levels of chloride and sulfate residues, which are often found together in tap water, but we had yet to diagnose the root cause of the failures.

Close up of Drip Trail around VHDM
connector

Our findings indicated that chloride residues were being deposited on the boards during ESS/Burn-in testing. Contaminated tap water was allowed to condense and drip down onto the sensitive VHDM connector, thus causing the electromigration to propagate and cause field reliability concerns. To eliminate the introduction of this contamination, we set up a cleaning protocol for the ESS chamber involving Scotch Brite pads and 10M Ω deionized water working from the top to the bottom of the chamber. The chamber should be scrubbed at least 3 times using this method, and then thoroughly wiped with a lint free cloth and deionized water making sure to clean all vents and air inlet openings. Then, the chamber should be wiped down 3 times with isopropyl alcohol using non-polyester critical contact wipes. The filter and

desiccant will need to be replaced, and clean deionized water should be used when testing in the chamber is resumed.
