Not-So-Fine Debris

Left uncleaned, even staging racks can be a source of failures.

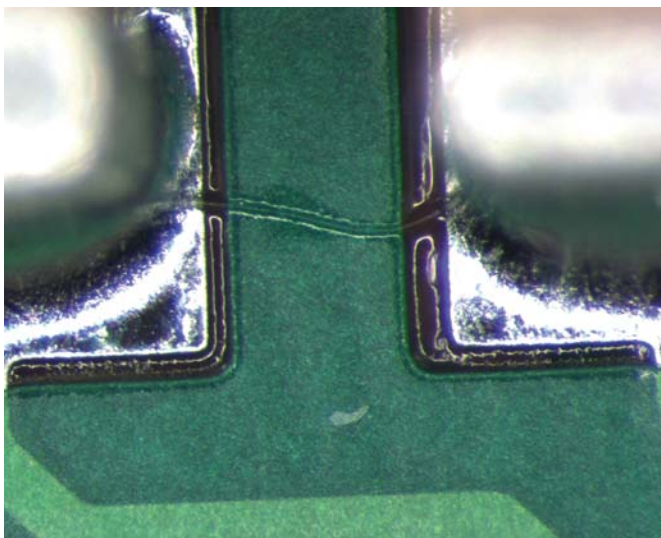
Figure 1. The battery circuit (shown at 150X magnification) revealed a debris pattern that was permitting flux to wick along the fiber surface, facilitating leakage.

We were able to measure leakage across this fiber and flux location. When we analyzed the residue from this 0.1" area of the assembly we found high levels of WOA residues.

Since we see the fiber debris on all nine failures, primarily on the second side, we tested the transfer racks from the process and found these microfibers in the racks and ESD tubs. Each rack and tub showed a dust and debris buildup that had never been cleaned, according to the floor operators. We recommend a thorough cleaning and plastic cover system of these racks. We also recommend investigating the use of a thinner stencil to reduce the flux amount, but only if a design of experiments shows the thinner stencil will achieve the same solder joint quality required for your product.
