## The Failure of a Circuit: Reliability Effects of Process Residues By Terry Munson, Foresite Inc.

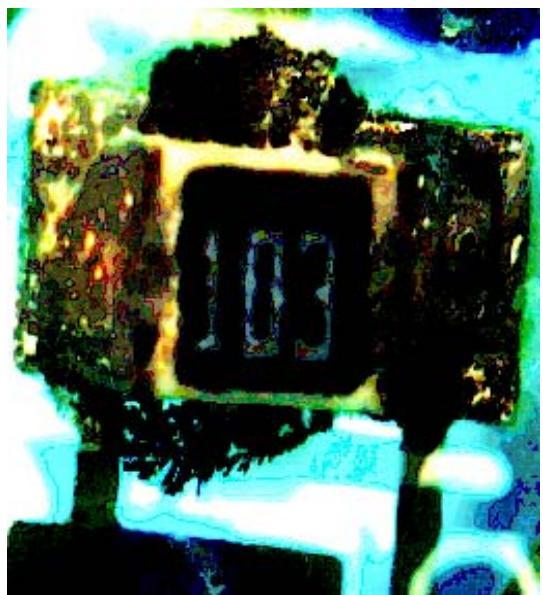
Figure 2

3<sup>rd</sup> is a corrosive residue that will create the deplating of the anode and carry the metal salt into solution and allow plating along the current path (dendrite formation as seen in the photos).

for the electromigration failure to occur. With a power requirement of as little as 1.5–2.0 volts to drive the dendrite formation, nearly all electronic circuits are susceptible to this type of failure criteria (as long as the three conditions exist). Generally, a failure occurs when the spacing between power and ground is connected by a thin layer of moisture that combines the corrosive residues and the voltage to create a metal dendrite that shorts the circuit. This conductive metal path creates a short circuit on an assembly in the field, and this assembly is then returned to the manufacturer where a typical failure analysis is performed. This typical failure analysis will often include a SEM/EDX analysis showing the following elements: carbon, oxygen, tin, lead and copper. This elemental investigation provides some wonderful photos of the dendrite, and shows that copper, tin and lead metals were the metals that created the short, but it doesn't tell us what caused the dendrite to grow.

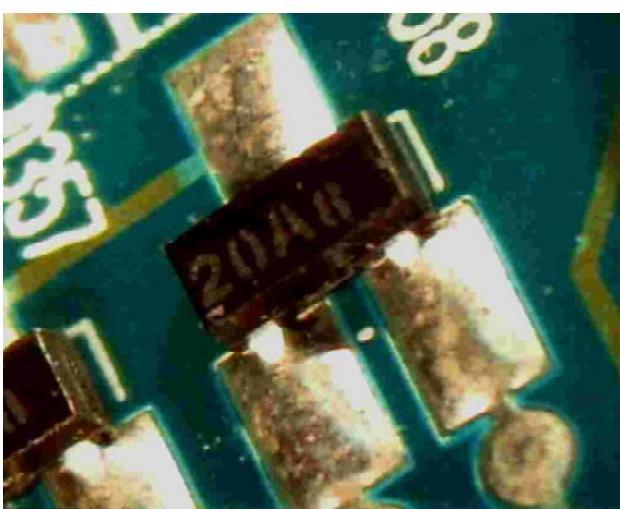
$3^{rd}$  is a conductive residue that will carry a current along the current path (no dendrite formation will be seen – see photo).

opportunity for a thin layer of moisture and conductive residue to form creating a leakage path (bridging these circuits). These electrical leakage failures differ from electromigration failures in that no actual metal migration takes place causing a hard short. This failure mechanism consists only of stray voltage on the surface of the circuit board affecting the sensitive circuit. Moisture is absorbed by the surface residues to create this conductive film but does not contain a level of corrosive residue to cause electromigration. Figure 3 shows an assembly that failed due to electrical leakage of 1.54 volts on a 12-volt input.

These failures will appear as no trouble found (NTF) field returns. This happens because of a moisture opportunity in the field creating the failure. When the failed board is tested on the bench, it works fine. These failures can be placed into a high humidity chamber (65% RH) for a short period of time (4 hours) and retested. If the units fail after this procedure, it is because they have a leakage problem. These failures can be baked out at 125° F for 3 hours to return them to good working condition, but will continue to fail when exposed to high humidity. A corrective action for these failures is to properly remove the flux residue or to complex it somehow.
