## **Tin Whiskering on PCBA Capacitors in Storage (Inside ESD Bag, Inside a Sealed Cardboard Box)**

Terry Munson  
Foresite Inc.  
Kokomo, IN, USA  
terrym@residues.com

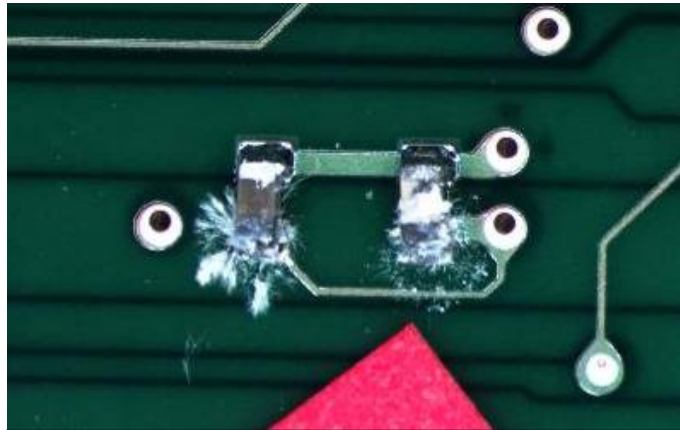
Figure 1 – Capacitors with tin whiskers growing on surface of tin plating.

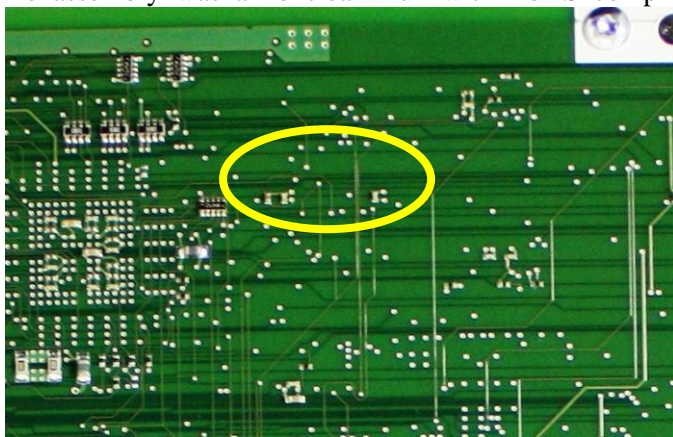
The assembly was a no clean flux with RoHS compliant solder (SAC 305) and components on an immersion silver bare board - no visible whiskers were produced anywhere but on the capacitors on the bottom of the PCBA with a battery circuit.

Figure 2 - Bottom side of PCBA (area of interest)

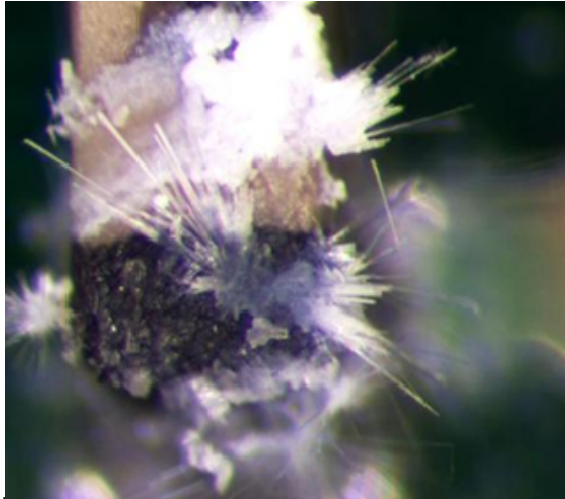
An interesting fact was that these three capacitors were inside the ESD bag inside a box with foam pressing the bag across the surface of the capacitors. This apparently caused a short circuit across the surface of the capacitors, causing the power side of the capacitor to heat up. This did not cause

Figure 3 – Capacitor #1 with tin whiskers on power input side

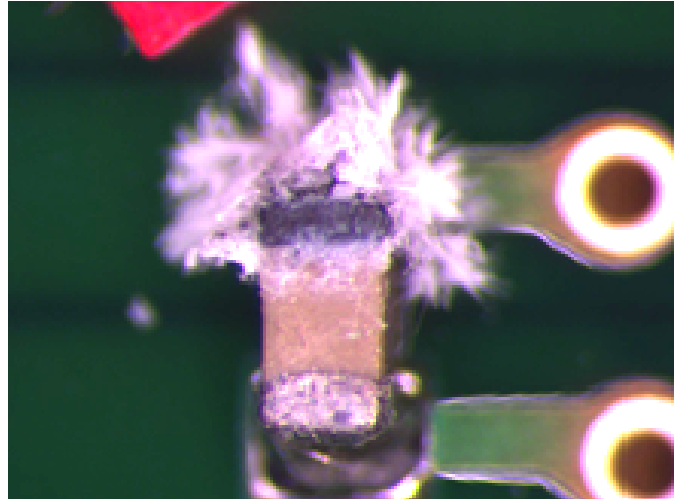
Figure 4 – Capacitor #2 with tin whiskers on input side only

The thermal image shows that with the three volts shorting across the component surface at a temperature of xx.x C was enough to soften and release the dissipative residues inside the ESD bag to create a localized chemical soup. This microenvironment around the capacitor created the conditions that accelerated the formation of the thousands of tin whiskers that formed - only on the power input side of the component. If the component would have been dirty from fabrication both sides of the exposed tin metallization would have reacted similarly. The photo above (Figure 4) shows one of the capacitors with all of the exposed tin consumed to form the whiskers.

Figure 4 shows only crystal formation on the impure side of capacitor #2. There was no visible corrosion on the vias of the immersion silver or on the output side metallization.

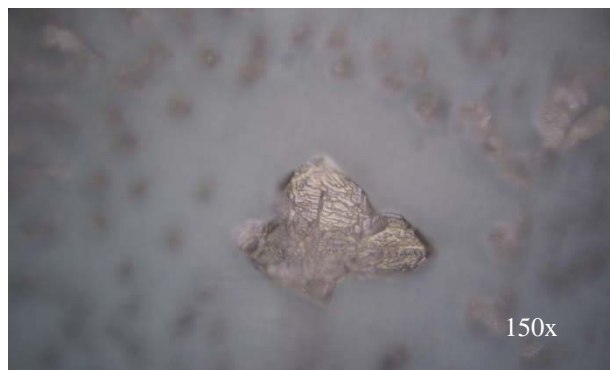
Figure 5 – Inside ESD bag surface above capacitor #2

Inside the ESD bag we see surface differences only above the direct contact points of the capacitor. It appears that the inside waxy chemical dissipation material was heated and cooled only over the capacitor.

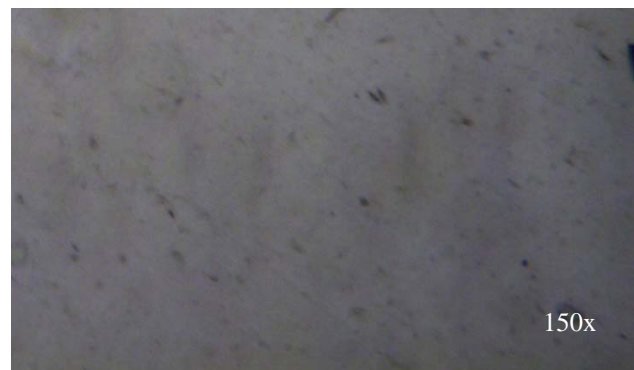
Figure 6 – Inside ESD 1inch away from capacitor #2

Inside the same ESD bag 1 inch from capacitor #2 we see no evidence of melting or change to the surface of the ESD dissipative material.

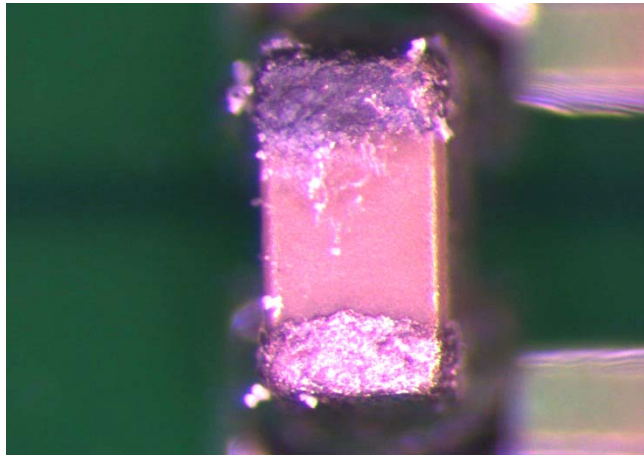
Figure 7 – Capacitor # 8 showing tin corrosion and small whiskers forming on surface

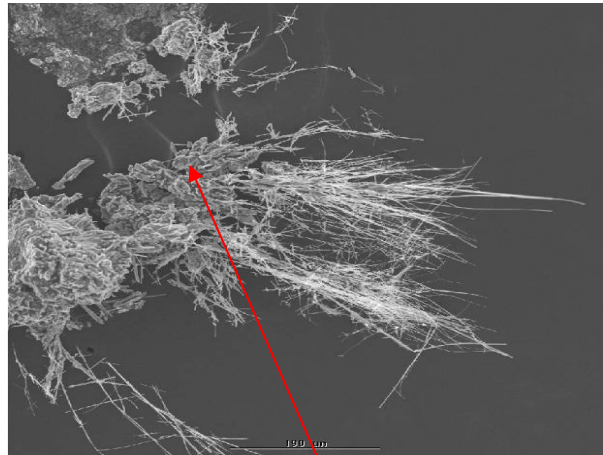
Figure 8 – SEM of whiskers removed from capacitor

The image of the whisker shows the formation of the single crystal tin structure from the base of the tin plating.

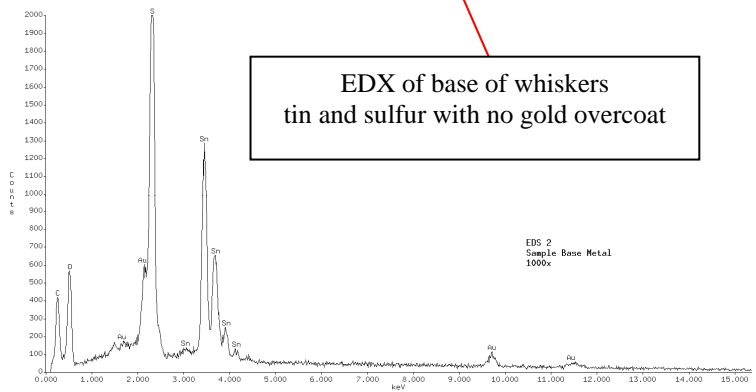
EDX of base of whiskers  
tin and sulfur with no gold overcoat

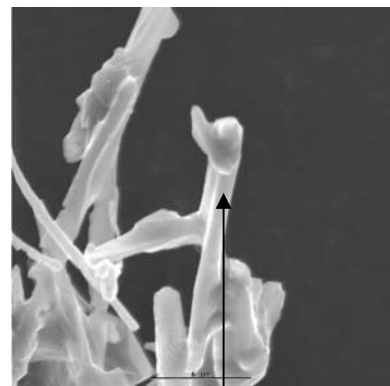
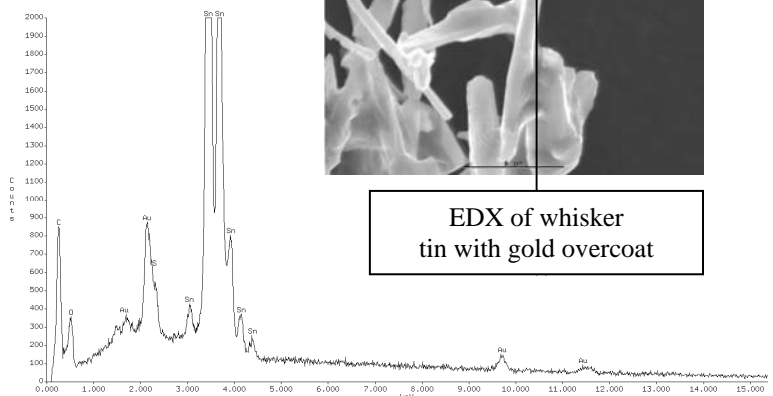
EDX of whisker  
tin with gold overcoat

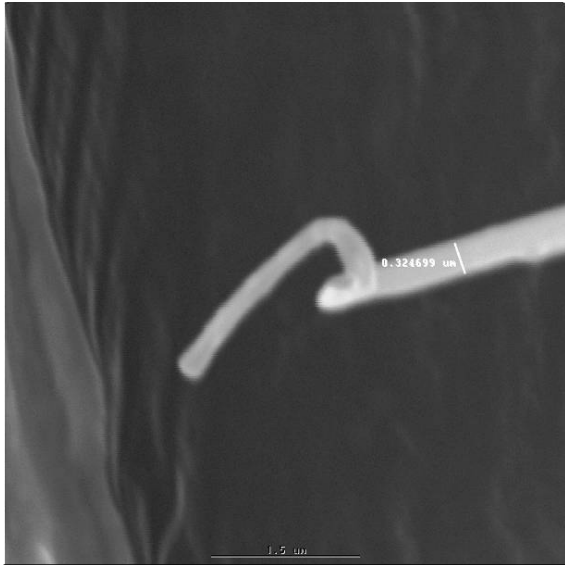
Figure 9 – SEM of whiskers removed from capacitor

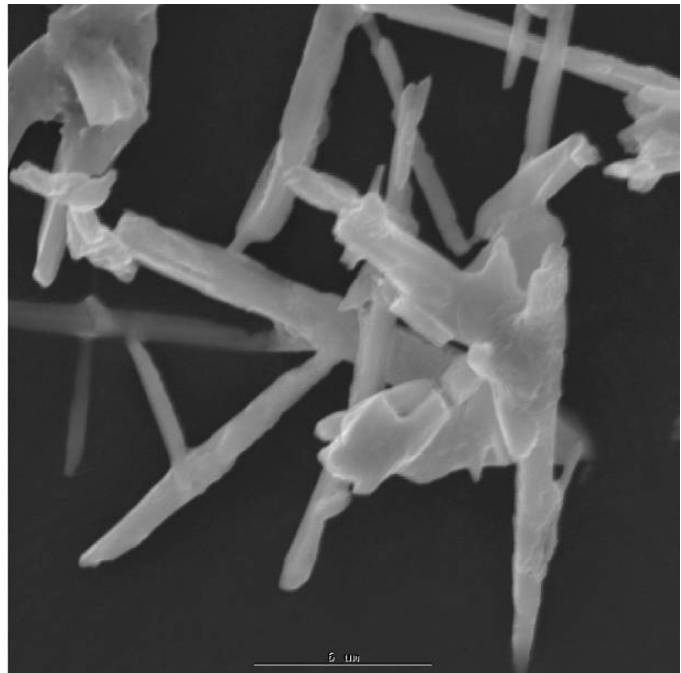
Figure 10 – SEM of whiskers removed from capacitor

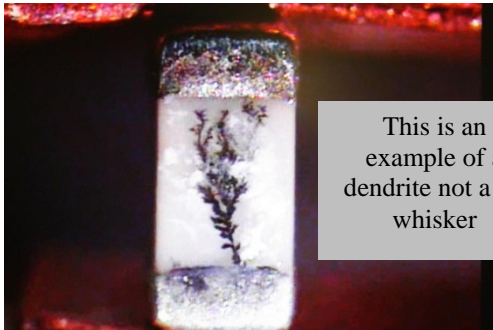
This is an example of a dendrite not a tin whisker

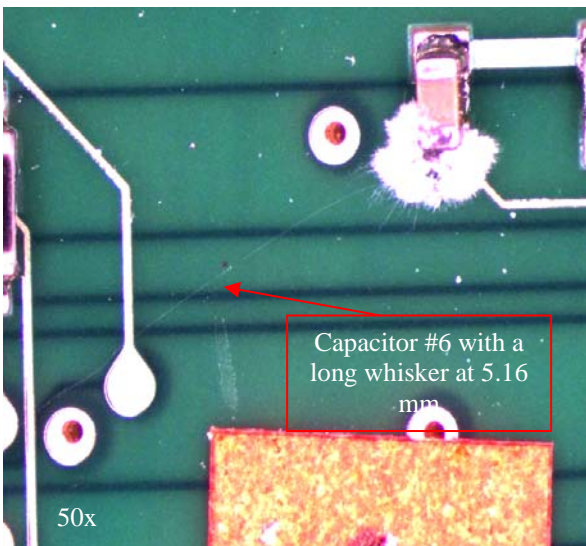
Figure 11 – SEM of whiskers removed from capacitor

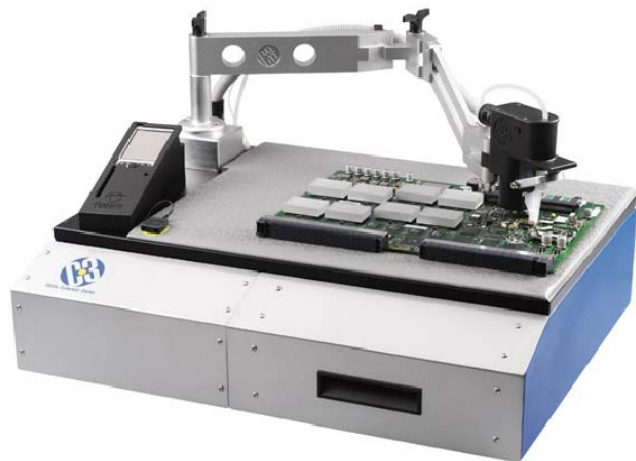
Figure 12 – C3 test system for localized extractions

To isolate the areas of the circuit board and ESD bag we used the C3 extraction and test system to determine the specific area cleanliness and electrical effect on the test electrode in solution after the extraction. Due to the small area configuration of the 0402 components we choose the smaller C3 test cell (the extraction area is the size of an 0805 chip component) which extracts a 0.02 in<sup>2</sup> area of the board surface and has an extraction volume of 2.0 mls of extraction solution.

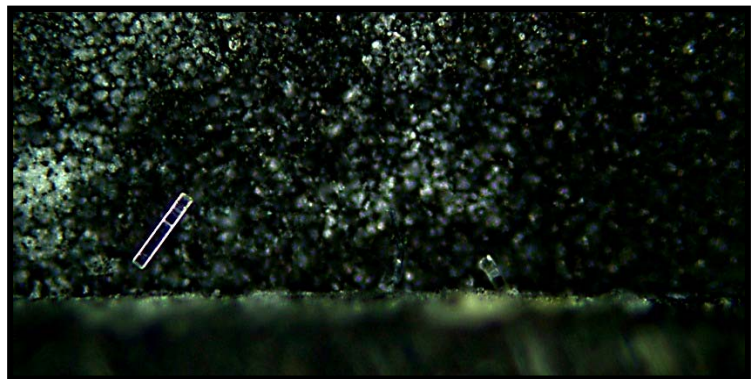
Under similar conditions, Foresite was able to grow tin whiskers on the surface of the tin plated electrode with the ESD bag and the 3.3 volt battery in a sealed bag in 5 days, which indicates that the mechanism is reproducible.

Foresite sample grown in 5 days at 1000x under ESD bag
