White Residue on Finished Assemblies: Is it Good or Bad?

White residues, particularly on no-clean assemblies,
are often benign & insulative

Foresite Inc.

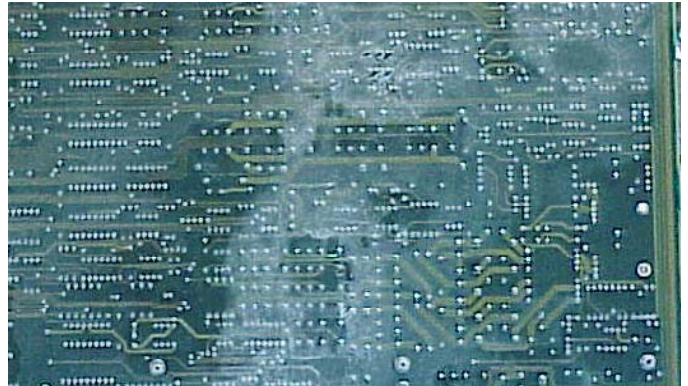
Figure 1: white residue from no clean flux hand soldering

In many of the cases we have seen, the white residue is primarily due to the reaction of moisture and flux residue. We have also seen dryfilm soldermask absorb cleaning chemistries and water to create a white hazy surface. In the first photo, you see a typical hand solder application with a low residue flux, this material is intended to be left on the assembly without cleaning. The area around the solder joint is shiny compared to the finish of the standard laminate. This may be a cosmetic issue that arises when some assemblers are trying to remove the evidence of flux residue with a standard benchtop cleaner or with alcohol and a brush, then rinsed with water. This reaction with water from rinsing a partially cleaned flux residue is typical. If the residue is from a water-soluble flux, many times this material contains activators that are very conductive, moisture absorbing and corrosive. These residues must be removed if they are water-soluble flux residues. The low solids do not need to be removed, but the bare board and components must be cleaned so that they do not contain surface residues that are corrosive or conductive (HASL flux and plating bath residues).
